Municipal Case Study

First-ever TerraBrute® Product in Excellent Shape 20 Years after Installation

Rigorous testing proves PVC pressure pipe system still an industry leader

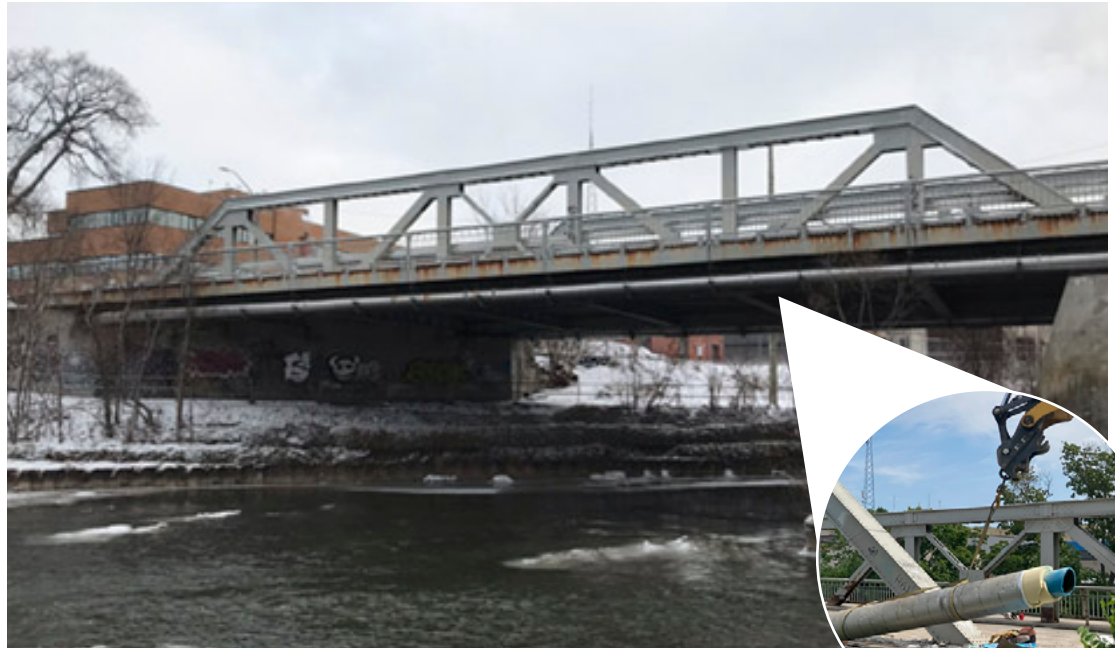
TerraBrute was removed and evaluated. when Ridout Street Bridge reached the end of service life in 2019.

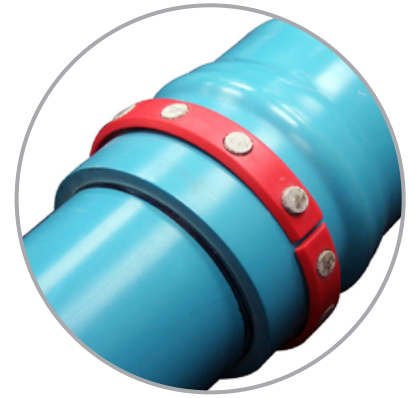
Non-Metallic Ring-and-Pin Joint Design

In fact, the Ridout Street bridge crossing was an ideal application for TerraBrute® and its non-metallic ring-and-pin joint design. This innovative design provided easy installation on this bridge. Traditional butt fusion techniques would have been difficult, especially for the span of suspended pressure pipe, that needed to be installed beneath a busy roadway bridge.

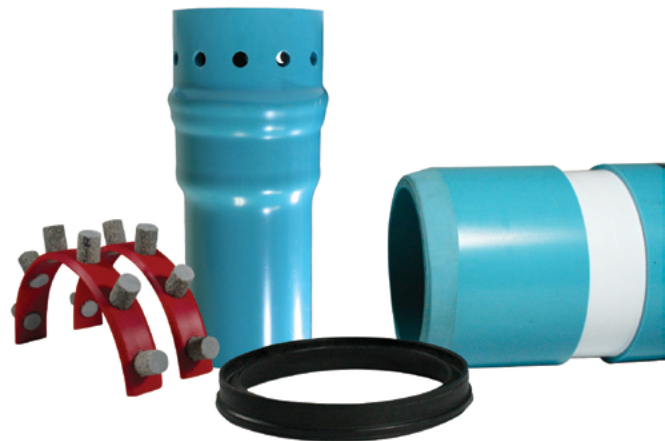
According to IPEX technicians, the first impressions of the pipe were impressive. Visually, the pipe appeared to have maintained a vibrant colour and a smooth surface, and the cross-sectional area showed no signs of degradation.
